Marine Notice 11/2013

## Fatality resulting from air reservoir drainage operation

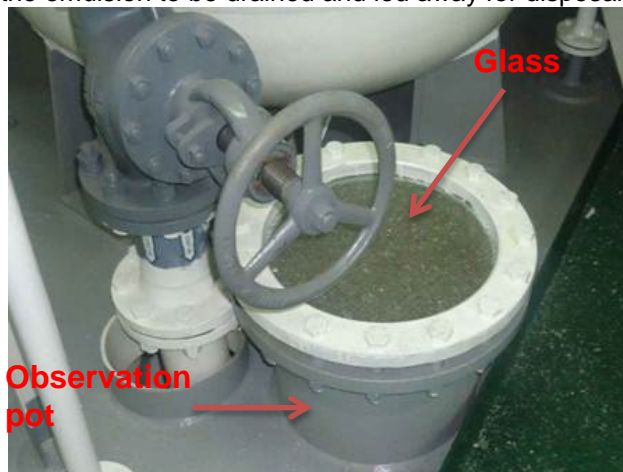
On this vessel the blow down pipe from the reservoir after the drain valve is led to a small cylindrical observation pot, the top of which is covered by an observation glass attached in place by bolts and a flat steel retaining ring. At the bottom of the pot a small hole of approximately 10-12 mm is drilled which allows the emulsion to be drained and led away for disposal.

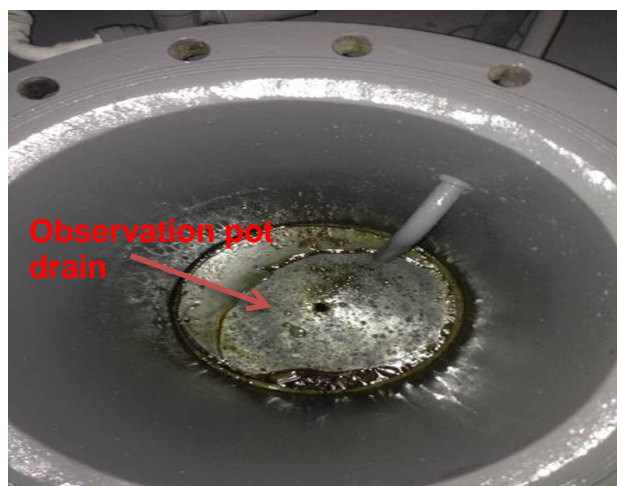
Although, it is not clear as to the actual sequence of events, it is understood that the fourth engineer was fatally injured when the glass on the observation pot of a main air reservoir exploded and the flying debris struck his face.

The design of this kind of blow down arrangement is relatively new and only a small number of vessels are found fitted with them.

All ship owner/managers, seafarers, classification society and independent surveyors, and all other stakeholders who come across a vessel with similar drainage arrangements are requested to take notice of this tragic incident and take appropriate actions.
