Marine Notice 15/2015

Free-fall lifeboat safety

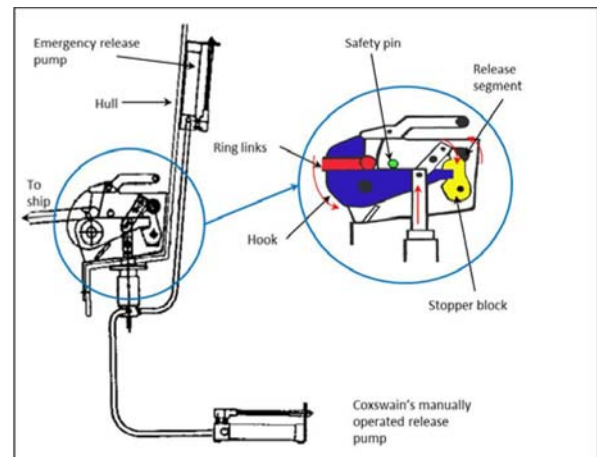
The ATSB identified that the Second Engineer accidentally activated the lifeboat's on-load release mechanism while carrying out a test procedure. When the Second Engineer cycled the hydraulic system, the retaining hook was released allowing the lifeboat to move down the launch ramp.

The ATSB found that the hydrostatic on-load release mechanism hydraulic cylinder ram had not fully retracted after use, preventing the stopper block from resetting correctly. This left the release hook in a partially disengaged position.

The ATSB noted that the design of the release mechanism cover plate prevented visual confirmation that the hook was correctly reset.

Aquarosa's free-fall lifeboat release system

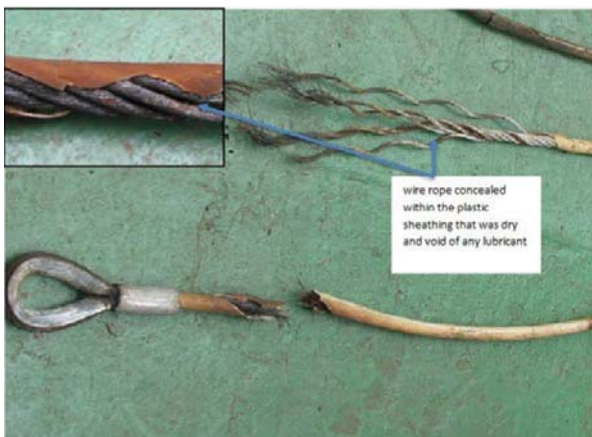
TAIC identified that the wire pennants parted under tensile overload. Subsequent testing confirmed that the sling wires had been significantly weakened by severe corrosion. This corrosion had gone undetected inside a plastic sheathing that the manufacturer had fitted to the wire.

The sheathing prevented the crew from identifying the corrosion and did not allow for lubrication or the application of other corrosion-inhibiting substances. The crew were also unaware of the necessity for greater vigilance and the application of anticorrosive substances during inspections.

Examples of the damage to *Da Dan Xia*'s wire slings after failure (Courtesy TAIC)

TAIC found that the wires were of adequate strength when manufactured, but that the sheathing allowed saltwater ingress, aiding corrosion by retaining water, and prevented external observation.

- Ships' crews following established maintenance procedures and being vigilant and observant during all maintenance tasks.
- The examination of maintenance procedures to ensure they are effective.
- Effective crew familiarization and training, to minimise risk when crew are conducting test procedures and training drills.
