Marine Notice 15/2015

Free-fall lifeboat safety

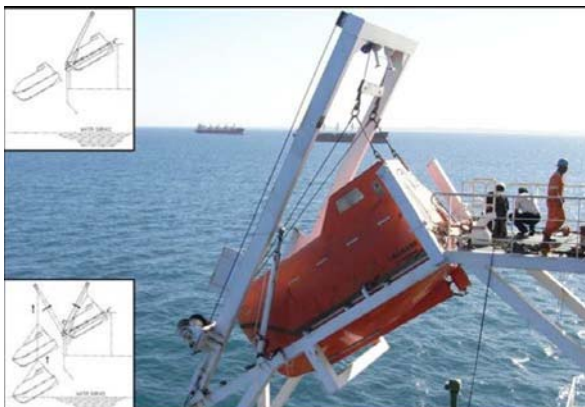
Aquarosa's Free-fall Lifeboat arrangement

The ATSB identified that the Second Engineer accidentally activated the lifeboat's on-load release mechanism while carrying out a test procedure. When the Second Engineer cycled the hydraulic system, the retaining hook was released allowing the lifeboat to move down the launch ramp.

The ATSB found that the hydrostatic on-load release mechanism hydraulic cylinder ram had not fully retracted after use, preventing the stopper block from resetting correctly. This left the release hook in a partially disengaged position.

The ATSB noted that the design of the release mechanism cover plate prevented visual confirmation that the hook was correctly reset.
